Manhole Inspection Summary

Manhole # S23I__006MH

Insp Date: **6/9/08 7:35 AM**

Location Address: **128 S Calhoun St**

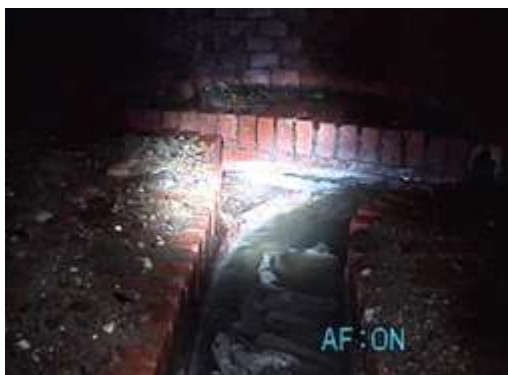
channel there is no 12 oclk pipe connect to mh next to it

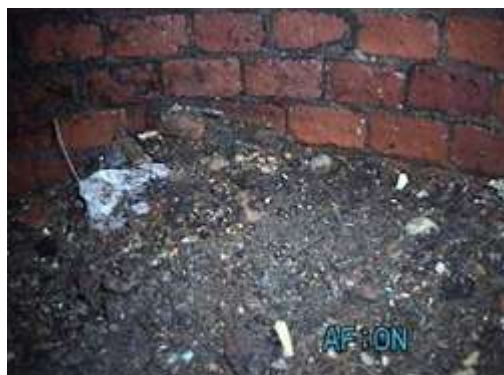
Defect 1

Condition: ☐ Sound ☐ Cracked ☐ Root Intrusion ☐ Deteriorated ☐ Leaks ☒ **Debris**

bench debris

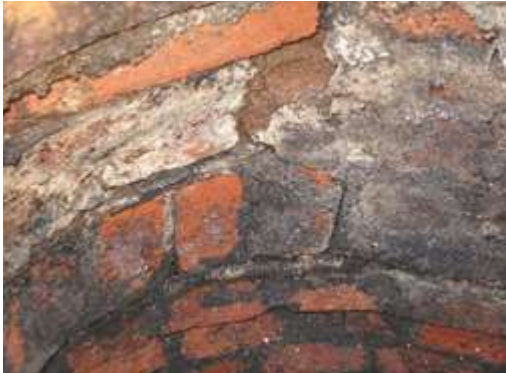
Defect 6

Condition: ☐ Sound ☐ Cracked ☐ Root Intrusion ☐ Loose Brick ☒ **Deteriorated**

Infiltration: ☐ None ☒ **Joint** ☐ Cracks ☒ **Mortar** ☐ Roots ☐ Wall

deteriated chimney top corbel

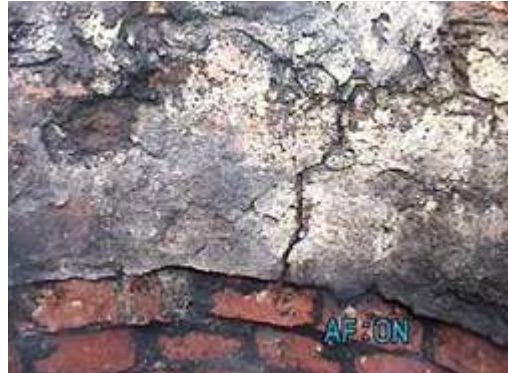
Defect 4

Condition: ☐ Sound ☐ Cracked ☐ Root Intrusion ☐ Loose Brick ☒ **Deteriorated**

cracked corbel

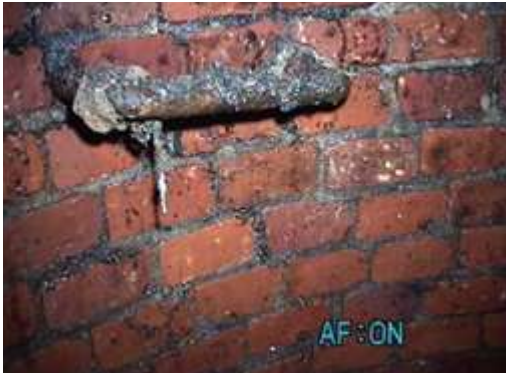
Defect 3

☒ **Evidence Of Surcharge** Depth: **10** (ft.) ☐ Active Surcharge Present

Evidence of surcharge

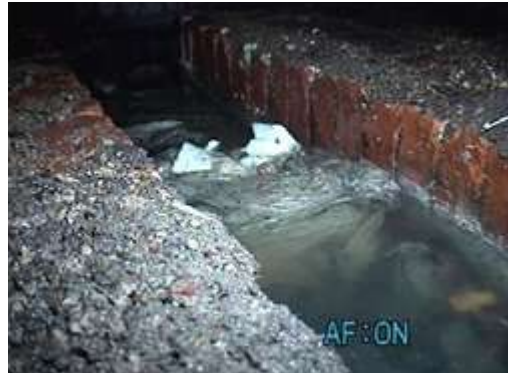
Defect 2

Condition: ☐ Sound ☐ Cracked ☐ Root Intrusion ☐ Deteriorated ☐ Leaks ☒ **Debris**

debris in channel

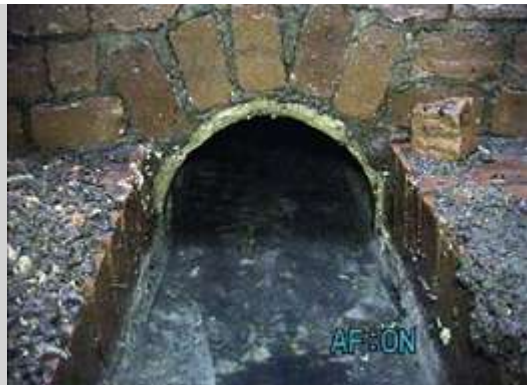
3 O'Clock Inflow

Deposits: ☐ None ☐ Mud ☐ Sludge ☒ **Debris** ☐ Grease

Silt Depth: **4** (in.) Deposits Extent: **Medium**
